Inspection Report

Lighthouse Property Inspections

Scott Siple ASHI #247339

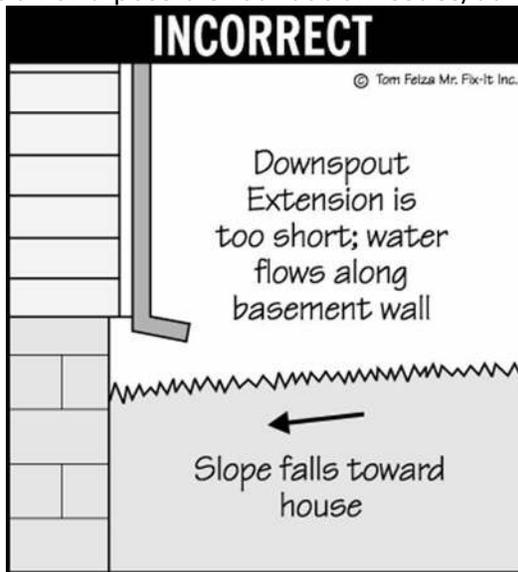
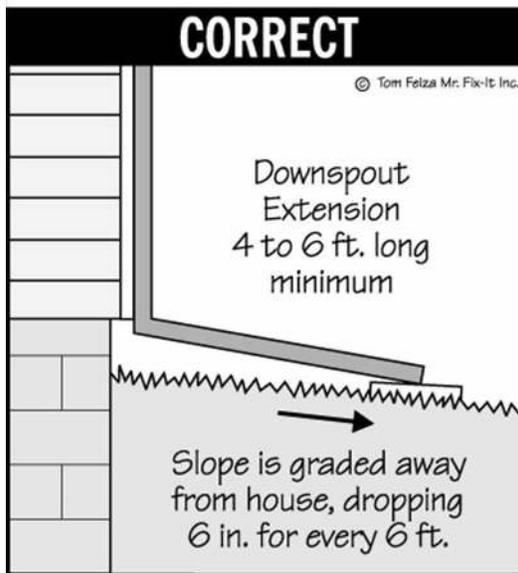
B003

- **Note:** One or more of the down spouts surrounding the property were found to be terminating too close to the foundation. It is recommended to extend down spouts leaders to discharge at least 3' away from building to reduce moisture penetration and possible foundation issues/damage.

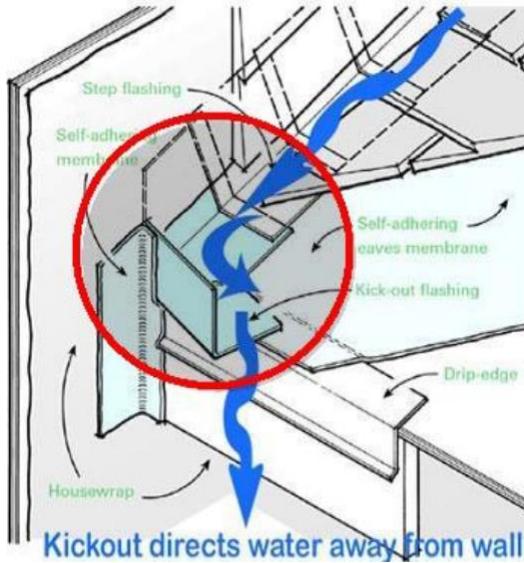
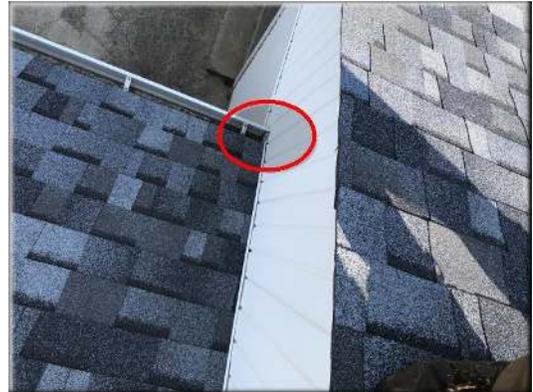
- **Recommendation:** Inspector recommends kick out flashing at the siding/roof junction areas. This flashing diverts moisture from the roof into the gutter and away from the siding.

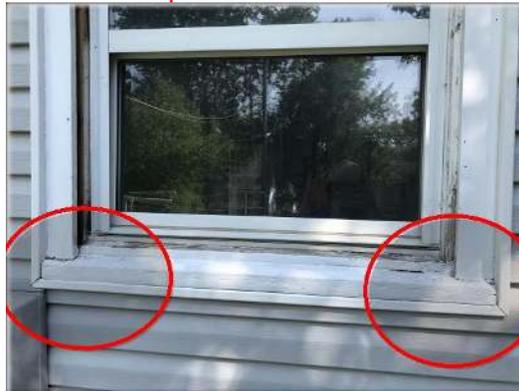
- Various pieces of exterior trim(windows and garage) were showing signs of weathering and/or deterioration at the time of the inspection. Continued deterioration will occur unless these issues are addressed soon.
- Recommend that the areas of damage of the property be completely evaluated by a licensed contractor to determine the amount of damage of siding, sheathing, etc. and cost for repair.

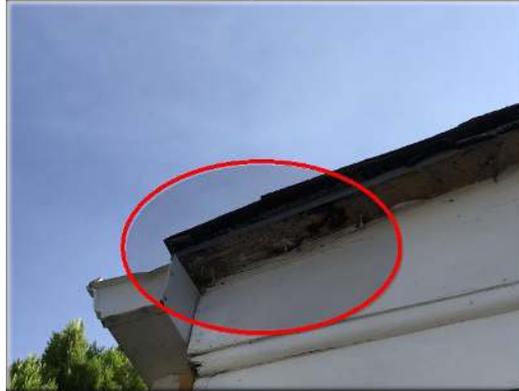
- Some of the various eaves and/or soffit areas located around the structure appear to be showing signs of deterioration and/or wear(right front). Exposed sheathing noted surrounding the property. Regular maintenance is required on these issues to maintain the lifespan of the materials.

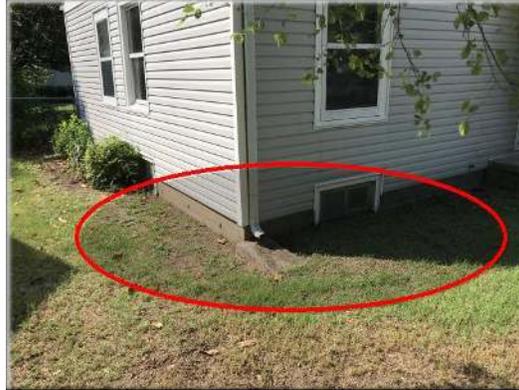
- Grading around some parts of the home are negative and slope toward the home(Left side, rear and front). Water may become trapped in these areas and could potentially damage the foundation. It is recommended that the owner install surface or area drains in these areas to help dissipate the water. Another alternative is creating a positive slope away from the property. It is recommended that the soil slope away from the structure at a slope of around 6" for every 10' of grade or 5%.

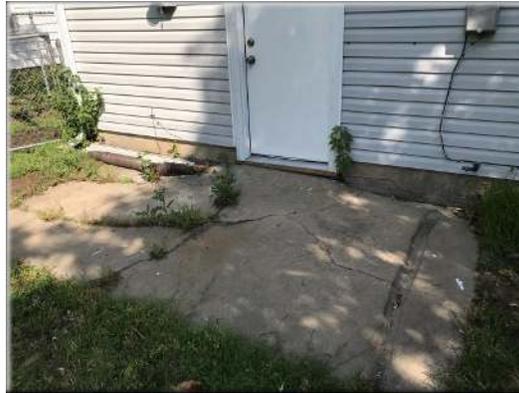
- Separations were noted to the sidewalk/driveway/rear slab area at the time of the inspection. It is recommended that these areas be repaired to prevent moisture intrusion and continued expansion and contraction. Repairs should be made by a licensed contractor to prevent further damage and prevention of any tripping hazards.

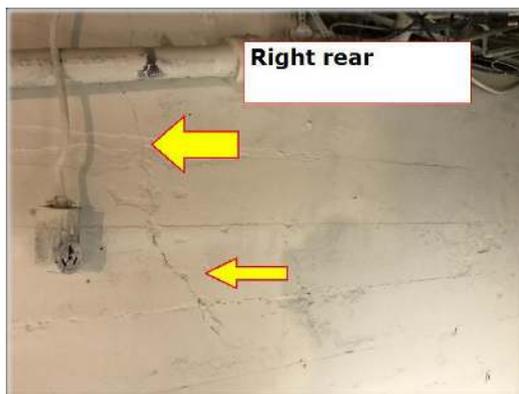
- Separations up to 1/8 were found in the foundation at the time of the inspection. Slight movement noted on the rear basement wall(diagonal separations at right rear corner). These findings are typically due to poor drainage resulting in water pressure on the foundation. Due to the findings at the time of the inspection, the inspector recommends that the foundation be evaluated by a licensed structural engineer and/or a foundation specialist prior to closing to evaluate the extent and possible repairs needed.

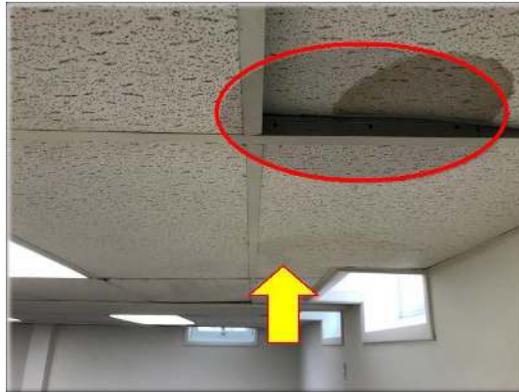
- One or more locations on the interior of the ceiling(living area) was reading abnormally high on the inspectors moisture meter. (Protimeter BDL5086). This is an indication of a moisture leak. It is recommended that the current owner be consulted about any moisture in the basement and repairs be made if needed by a licensed contractor.

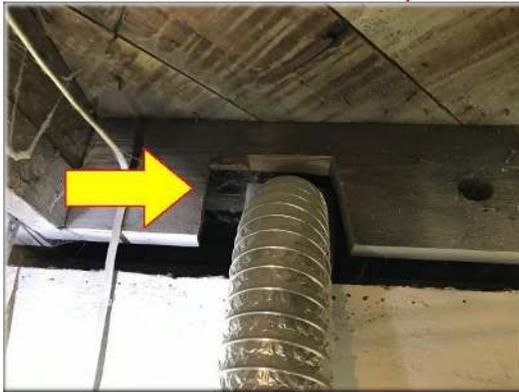
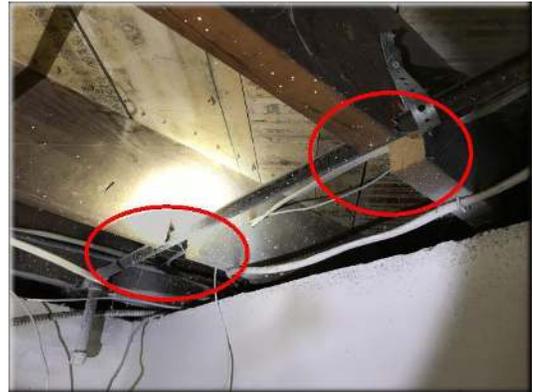
- The structural components(floor joists) that were visual at the time of the inspection were showing signs of notching which is against current standards. Recommend an evaluation and if needed, repairs by a licensed contractor. No structural movement, etc. noted at this time from these areas. Continue to monitor these areas closely.

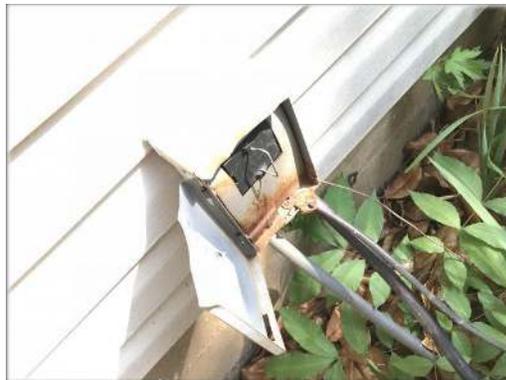
- The electrical disconnect box at the cooling system was loose and damaged at the time of the inspection.
- It is recommended that these issues be repaired or serviced by a licensed contractor.

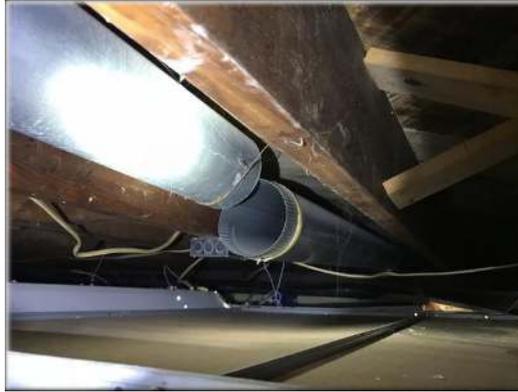
- Duct work found disconnected in the basement behind the suspended ceiling (Left rear).
- Recommend evaluation and repairs by a licensed contractor.

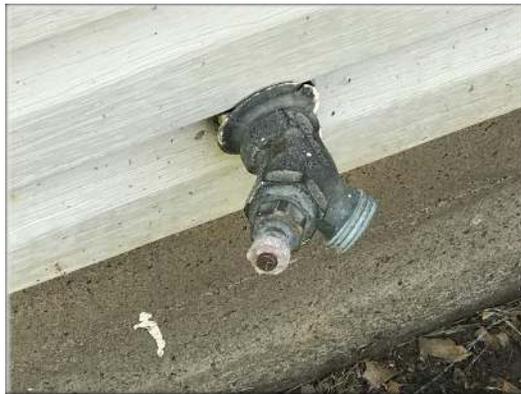
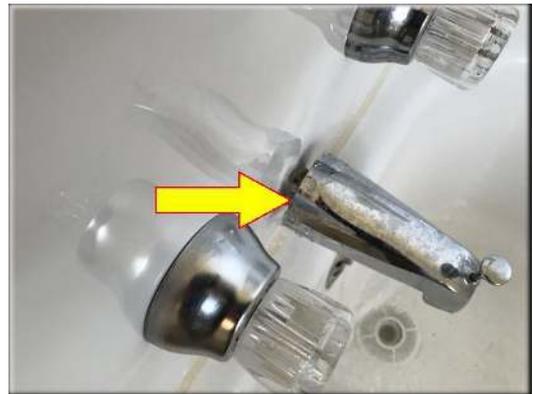
- One of the interior fixtures was found to be leaking and in need of repair at the main floor tub/shower valve area. Exterior faucet found missing handle(front).
- Recommend evaluation and repairs by a licensed plumbing contractor.

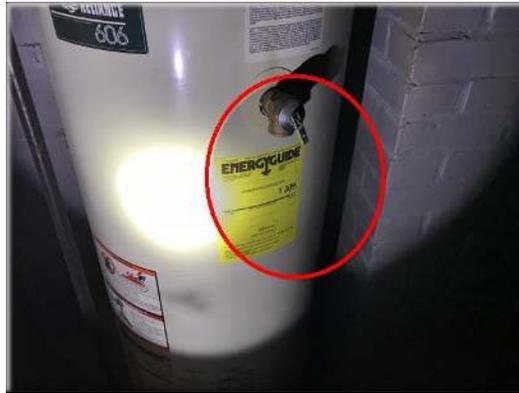
- No drain line from the TP&R valve was found at the time of the inspection. It is recommended that a minimum 3/4" drain pipe of proper material (copper or CPVC) be installed to properly direct the over pressurized/heated contents.
- It is recommended by the inspector that the unit be serviced and if necessary, replaced by a licensed contractor.

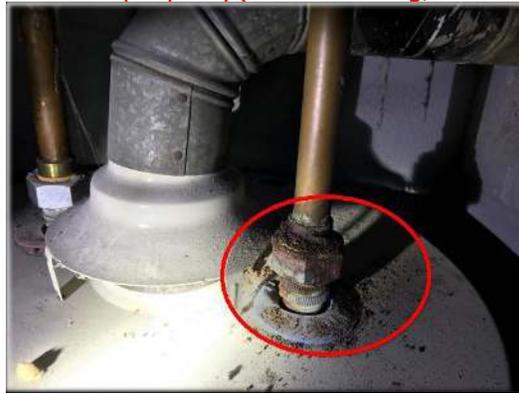
- The water heater water supply connection(s) were showing signs of rusting/corrosion at the top of the water heater at the time of the inspection. This can be caused by the water heater flue gases not properly venting and being drawn back into the property(back drafting/venting).

- It is recommended by the inspector that the unit be serviced and if necessary, replaced by a licensed contractor.

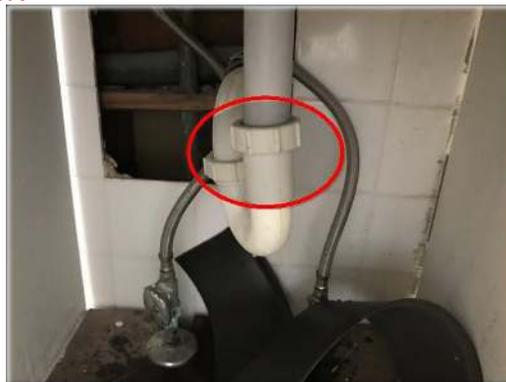
- A drain pipe was found leaking at then main floor bath sink.
- It is recommended by the inspector that the issue be repaired orreplaced by a licensed contractor.

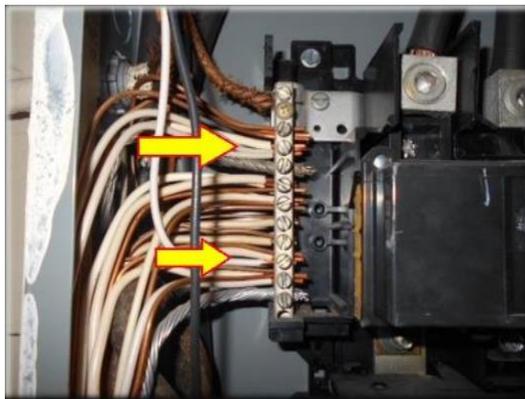
- **Two grounded conductors(neutral wires) were found entering the same area on the bus bar also known as "bundling". This is against current standards and should be repaired by a licensed contractor.**
- **It is recommended by the inspector that the issue(s) be corrected by a licensed electrician.**

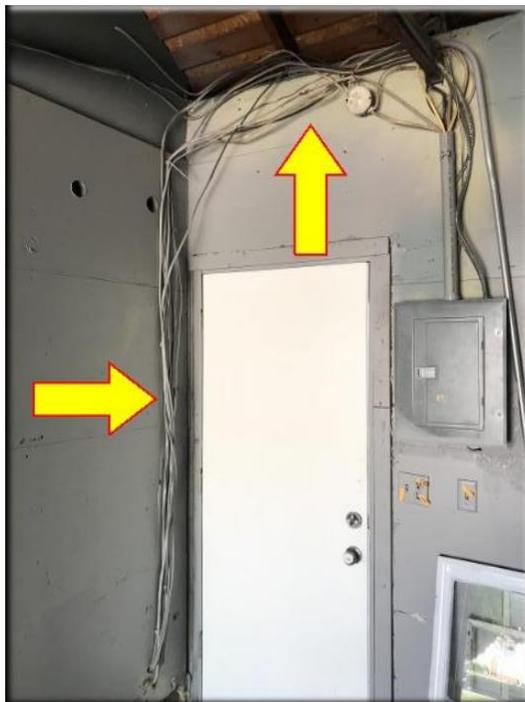
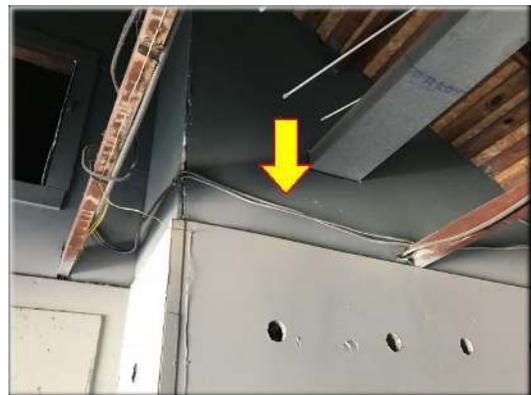
- Whole house fan not functioning.
- Non-standard wiring methods noted(garage). Wiring should run through the wall cavities or joists protected from damage, if not, this wiring should be protected in conduit. Current condition could cause wiring to be damaged, pulled, etc. and is unsafe.

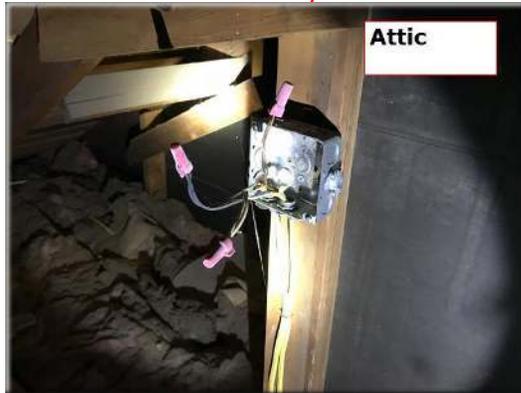
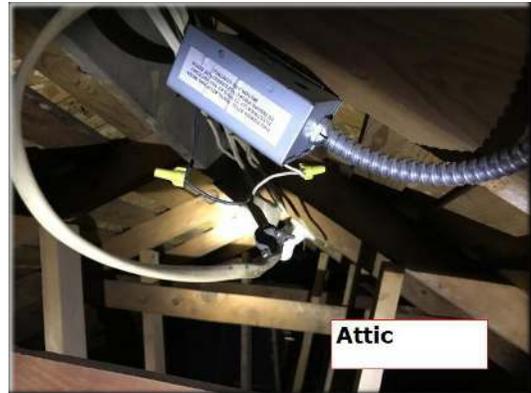
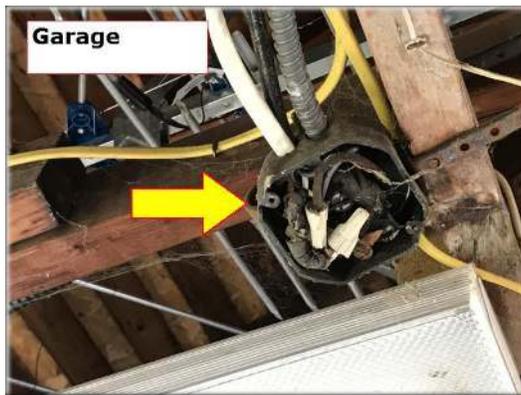
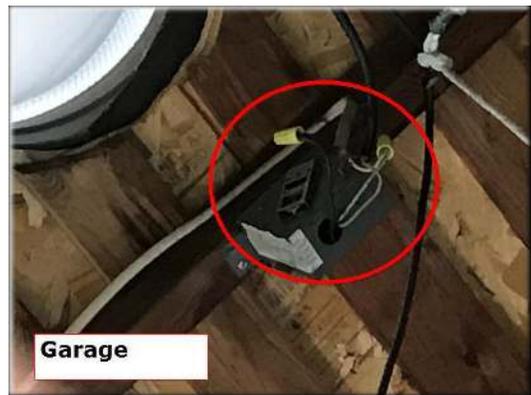
- Loose, damaged, open junction boxes and/or unsecured wires were found(attic and garage). Basement dryer outlet found loose and broken. Basement wall outlet found broken. These items should be secured, repaired and/or removed to ensure the safety of those working in the area.

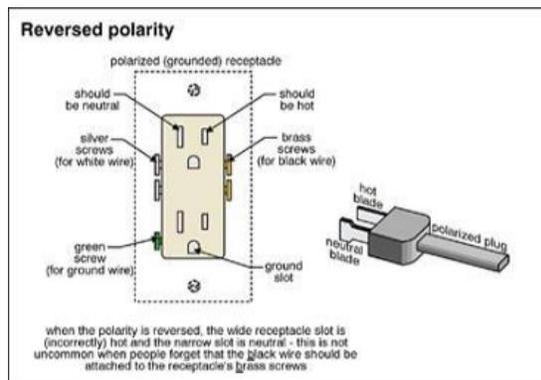
- Loose/ damaged outlet(s) noted on the property(kitchen and garage). This can cause the connections to the outlet to loosen over time and cause accidents/shorts.
- Outlet(s) and or Switch(s) were not operational at garage and basement bath(switches) and kitchen(switches and outlets). It is recommended that the owner be consulted as to the nature of this item and if needed, repairs be made by a licensed electrician.
- Reverse polarity found in the outlet(s) located at the garage rear wall. This is caused during the installation of the outlet by switching the hot(black) wire and neutral(white) wire on the outlet.

- The outlets, switches, etc. that have issues or were not functioning have been marked with a sticker unless other wise described by the inspector.
- It is recommended by the inspector that the issue(s) be corrected by a licensed electrician.

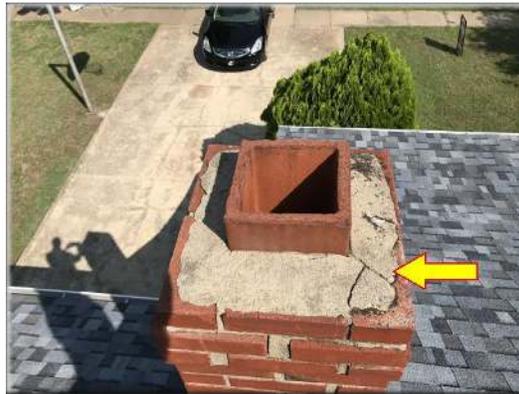
- The chimney crown was showing signs of damage and/or excessive wear at the time of the inspection. This is a possible entrance point for moisture which can cause failure of the liner, bricks, etc. that make up the chimney and flue system.

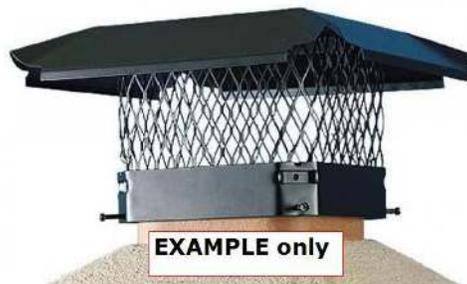
- The top of the chimney/flue was found without a screen/cover. It is recommended that this item be installed to keep leaves, moisture, animals and debris from entering the flue thus blocking the combustion gases from escaping and causing damage.

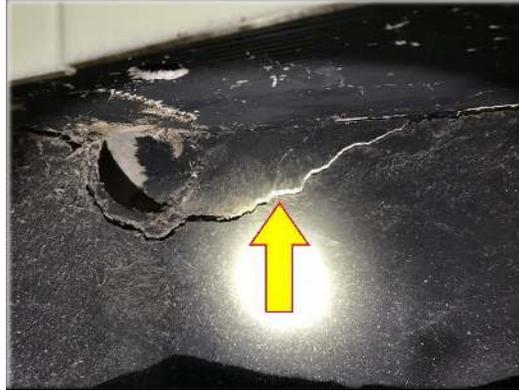
- There were cracks in the firebox area at the time of the inspection.
- Inspector recommends that this appliance not be used until it is evaluated and repaired by a certified contractor specializing in these appliances.
