Inspection Report

Lighthouse Property Inspections

Scott Siple ASHI #247339

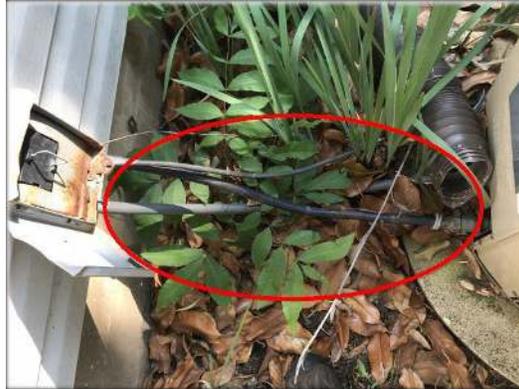
- The electrical disconnect box at the cooling system was loose and damaged at the time of the inspection.
- It is recommended that these issues be repaired or serviced by a licensed contractor.

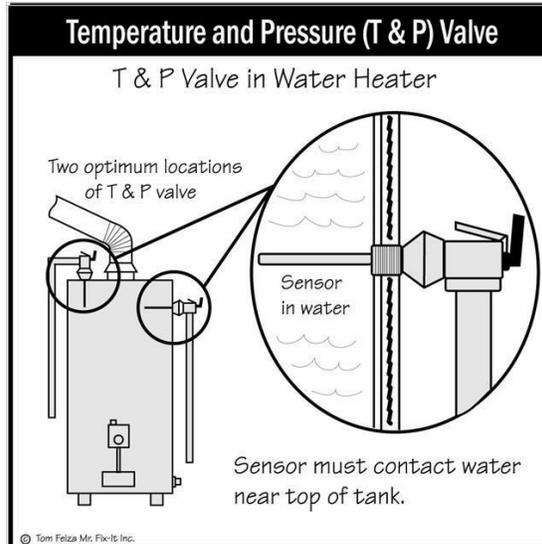
P038

- **Noted for location:** The TP&R valve and drain line exit point is located to the floor area. If water is ever seen coming out either of these pipes a licensed plumber should be contacted for a full water heater review. The TP&R valve should be tested yearly to ensure proper working of the device if it's ever needed.
- **Recommendation:** The inspector recommends that the hot water supply piping from the water heater have pipe insulation installed from the top of the unit for 3-5 feet to ease the operation of the water heater and assist with the utility costs associated with this appliance.
- **Note:** Current information recommends that the vent piping from the water heater be larger than 3". This size of pipe might not provide a proper draft for the combustion gases to escape up the pipe which means they could enter the home.

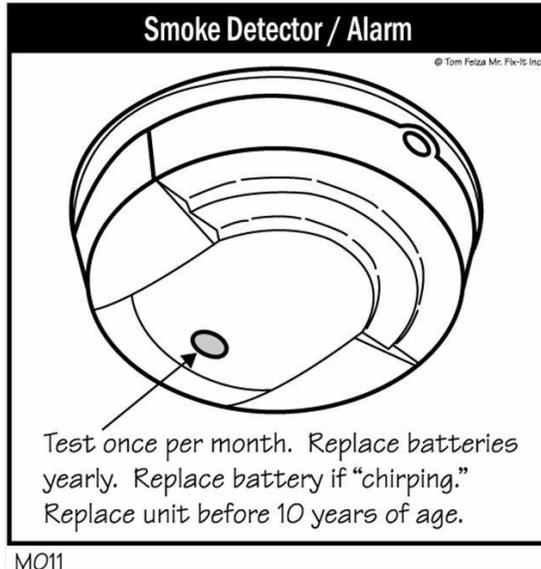
- Note: Given the current state of smoke alarm technology and facts found therein, the inspector is recommending the use of photoelectric smoke alarms (*labeled as Photoelectric or P*) and discourages the use of ionization smoke alarms (*labeled Ionization or I*). Current studies indicate Photoelectric Smoke alarms will activate more readily, particularly during the initial smoldering fire conditions. All ionization alarms should be replaced with photoelectric smoke alarms.
